## *Section 2*

### *The Clock Serial No 3824*

## 2. The Clock

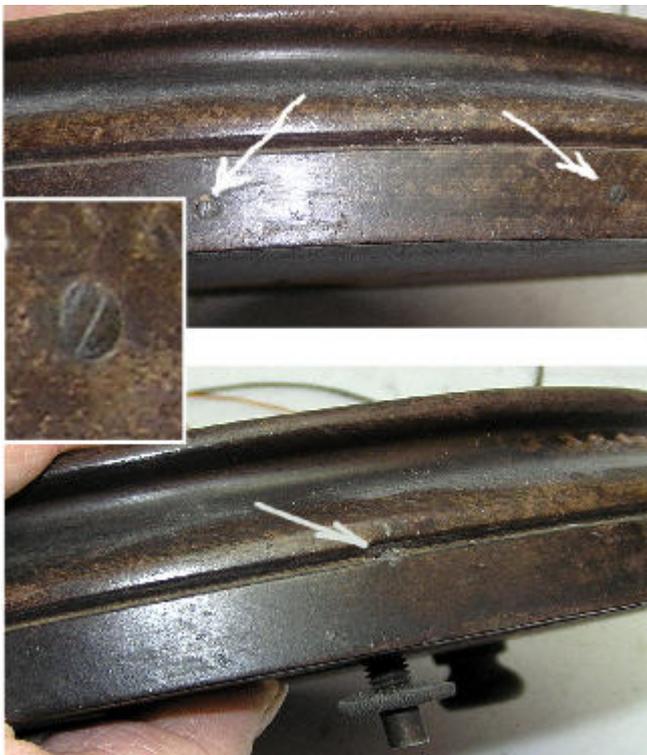
**Photo 2/1**

The original brass nails are still in situ at the front (**Photo 2/1 and inset**) and the remains of the wire-can still be found at the back where it was - retained in a small hole, shown in the insert photo.

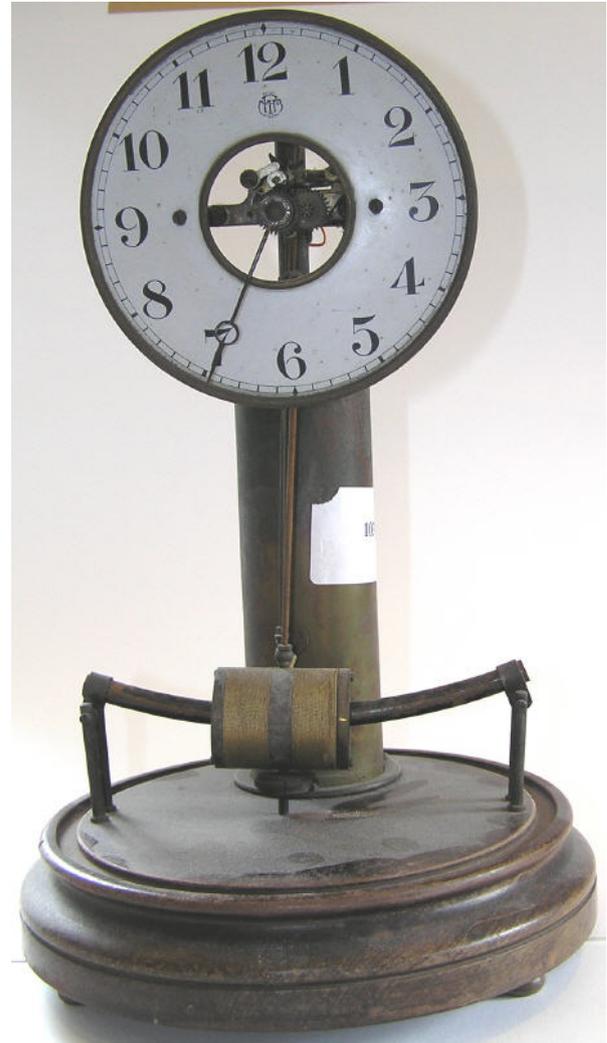
**Photo 2/2**

This clock (**photo 2/2**) is an early version of the "Tall Movement" under a dome, characterised by a cotton bound bob, moon hands, movement made from square section brass direct onto back plate, single driving pawl with separate retaining pawl, and over-slung damper. Later models have multi-plate movement with pillars, fine spade hands and metal clad pendulum bob.

The dial is still in reasonably good order and should look good when the brass is cleaned **(photo 2/2)** It should not need re-painting. The hour hand has been broken and will need to be replaced.

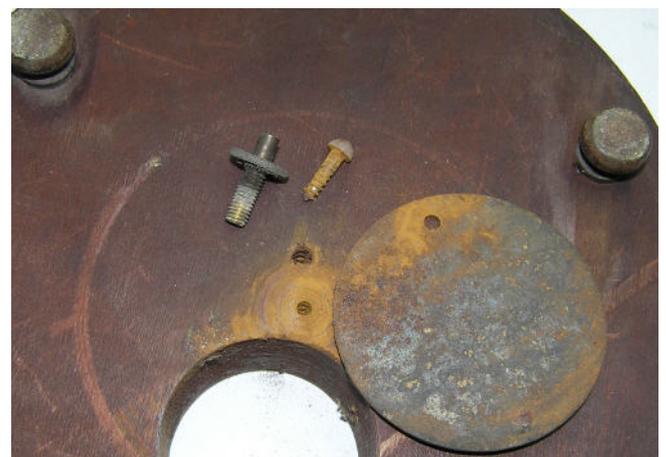
**Photo 2/3**

The name plate was lost early on in the clocks career as there is no discernable mark left on the wood. The original battery on these clocks were 1.5 volt Flag cells that sat up in the tube inserted through a cover in the base (**photo 2/3**). The unfortunate thing is that the battery often leaked acid and was left over the years to corrode the brass tube and retaining steel door.

This could be so bad as to eventually eat through the tube and show initially as a mottled surface which then later grows to more sizeable marks often turning green and in the worst cases leave gaping holes.

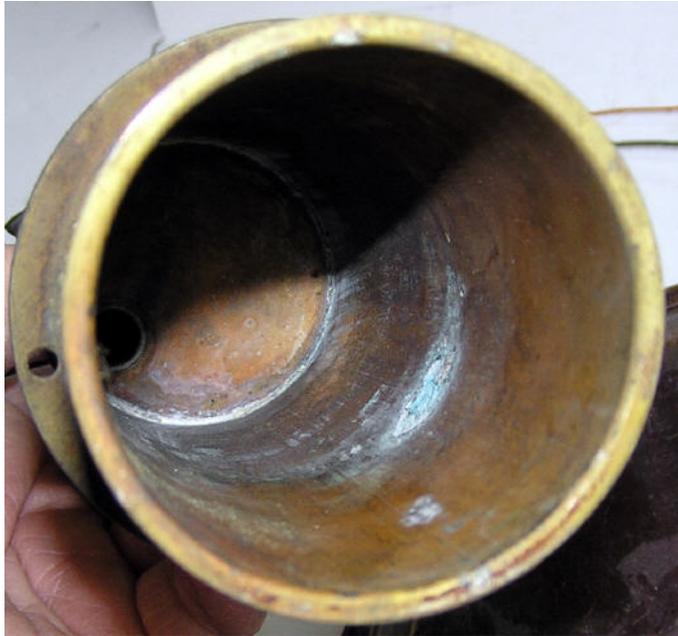
**Photo 2/4**

The suspension block as well as the associated screws, nuts and screwed rod are missing. On these earlier clocks the negative side of the battery was connected directly to the column via one of the screws in the base. As this need to be attached to one side of the

pendulum coil, the power had to be routed via a loop piece of silver plated wire across the gap caused by the silk suspension block. It looped from the top of the frame to the main iron rod of the pendulum. This particular clock is quite badly corroded on the inside but only shows the mottling on the outside. **(photo 2/4)**. We'll discover more after we start cleaning.

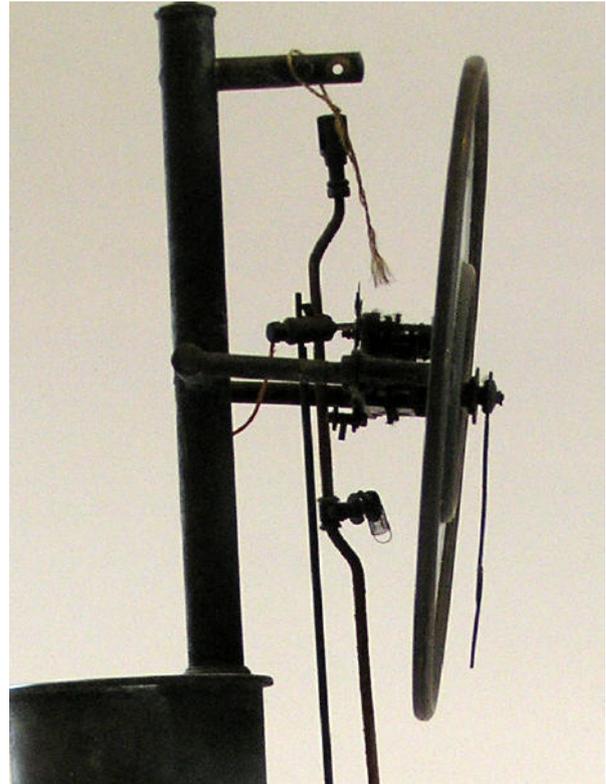
**Photo 2/6**

The movement retaining pillars are loose and hanging down at about 10 degrees and will need to be corrected **(photo 2/6)**. In this case someone has tried to attach the the battery directly to the pendulum via the contact pin assembly. This is a bad idea. It would badly affect the amplitude of the pendulum swing

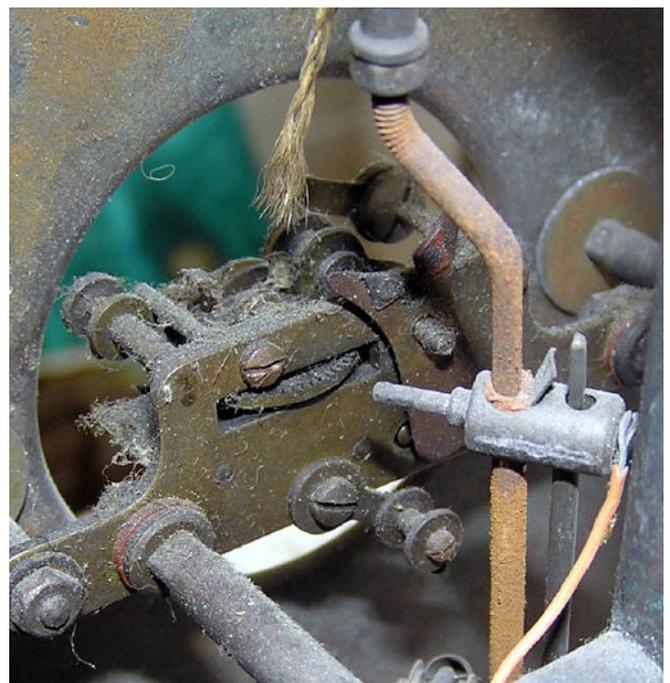
**Photo 2/7**

**(photo 2/7)**. The hex head bolt is missing from the back of the assembly.

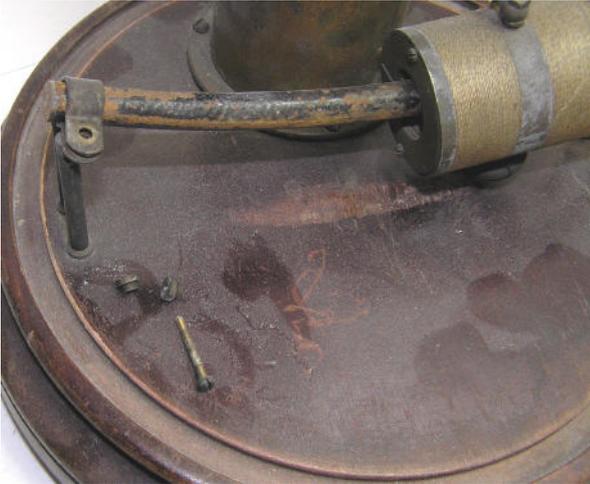
**Photo 2/8**

Also note in this photo the general condition of the clock. What isn't gummed up with oil and dirt is covered in rust. The base has been marked by the pendulum since the suspension has broken. This will need to be repaired and the whole base French polished **(Photo 2/8)**

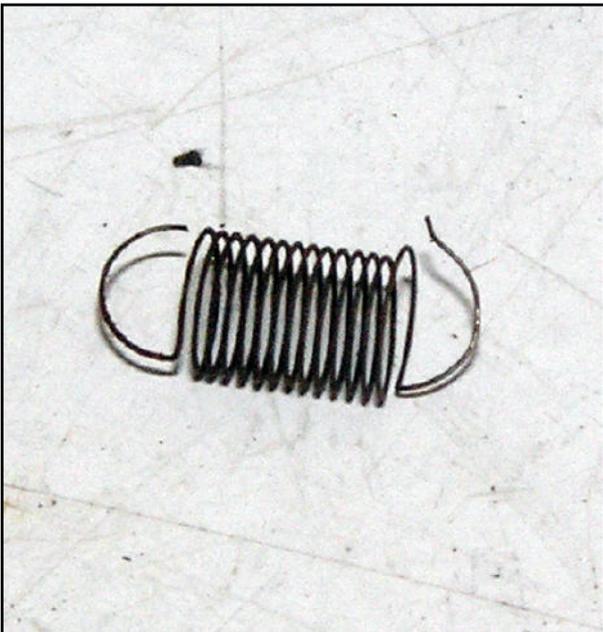
**Photo 2/9**

The Isochron spring is still intact and is hanging at one end only. It looks to be in good condition and is re-usable (**photo 2/9**). The Silver contact spring, however is completely missing and will be replaced.
